CONNECTICUT RIVER BASIN
FARMINGTON, CONNECTICUT
FARMINGTON RESERVOIR DAM
CT 00263

PHASE I INSPECTION REPORT
NATIONAL DAM INSPECTION PROGRAM

SEPTEMBER, 1980

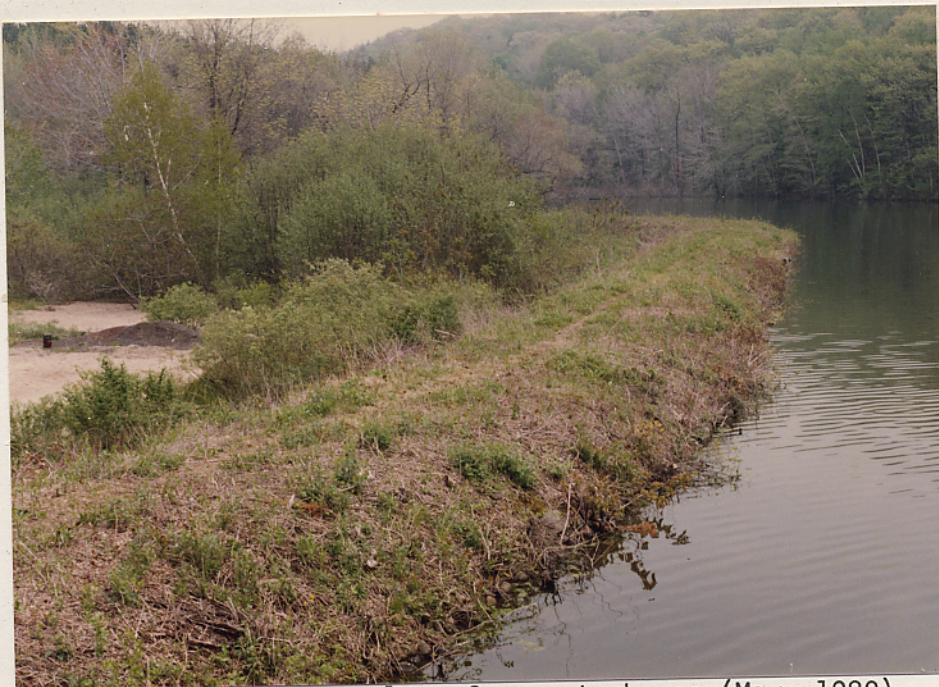
Top of Dam - The top of the dam is vegetated with grass and brush (Photo 1). A footpath traverses its length. An area of erosion was noted to the right of the gatehouse access bridge (Photo 5).

Photo 1 - Upstream slope from gate house (May, 1980)

6. Small trees and sumac on the slopes should be removed.
7. The gatehouse should be restored to a more accessible condition including repairs to the access ramp.

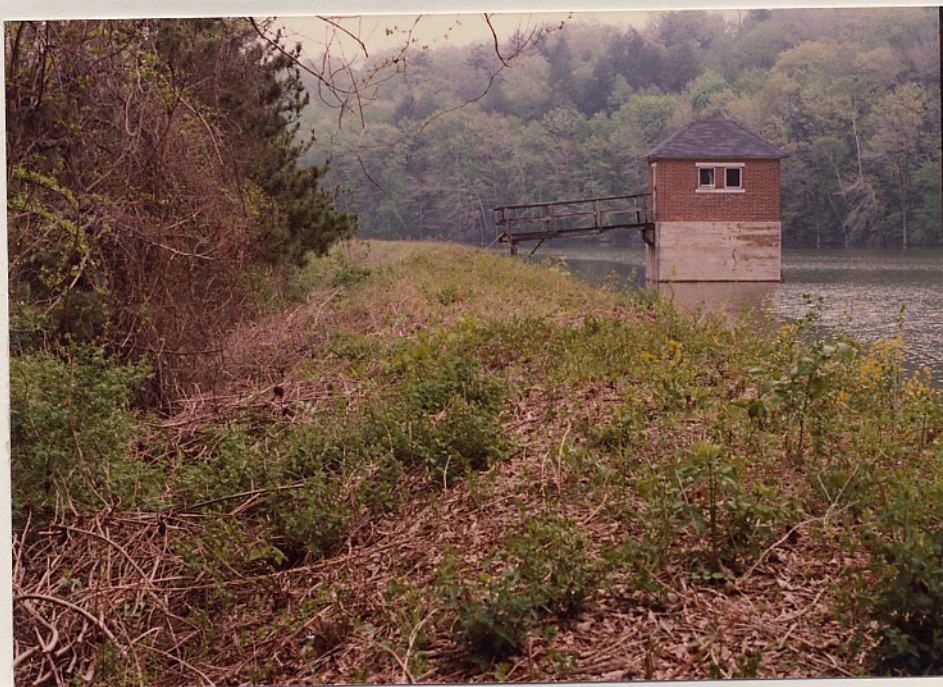
Photo 2 - Top of dam and downstream slope from spillway. Gate house in background, (May, 1980).

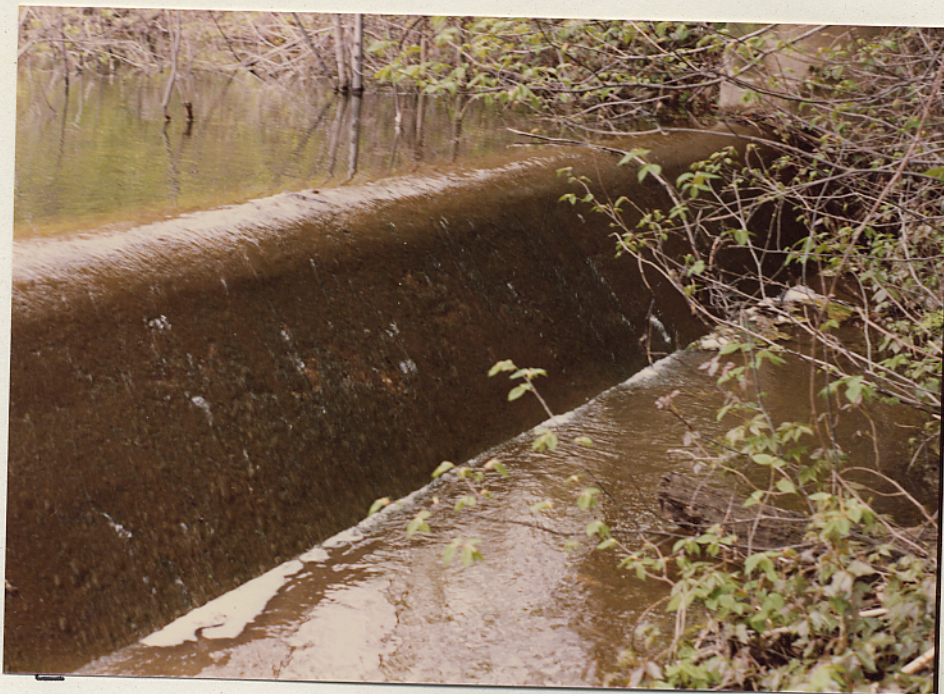
Photo 3 - Ogée shaped concrete weir at left end of dam,
(May, 1980).

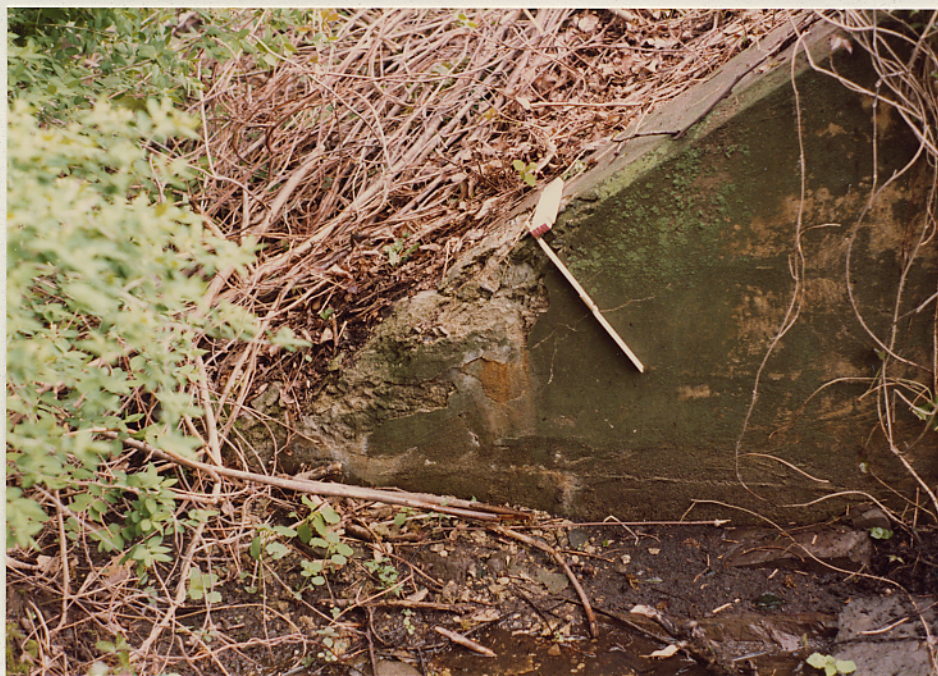
Spillway - The right training wall has some deterioration at the downstream end, exposing the aggregate (Photo 4). The concrete portion of the left training wall is in good condition, but a small downstream stone wall is broken up. The approach channel is riprapped near the spillway, but has brush and saplings growing farther out in the reservoir along the left side. The discharge channel has a stone bottom, some of which has been washed out.

Photo 4 - Deterioration of concrete at right spillway wall,
(May, 1980).

8. Deteriorated concrete at the spillway right training wall should be repaired.

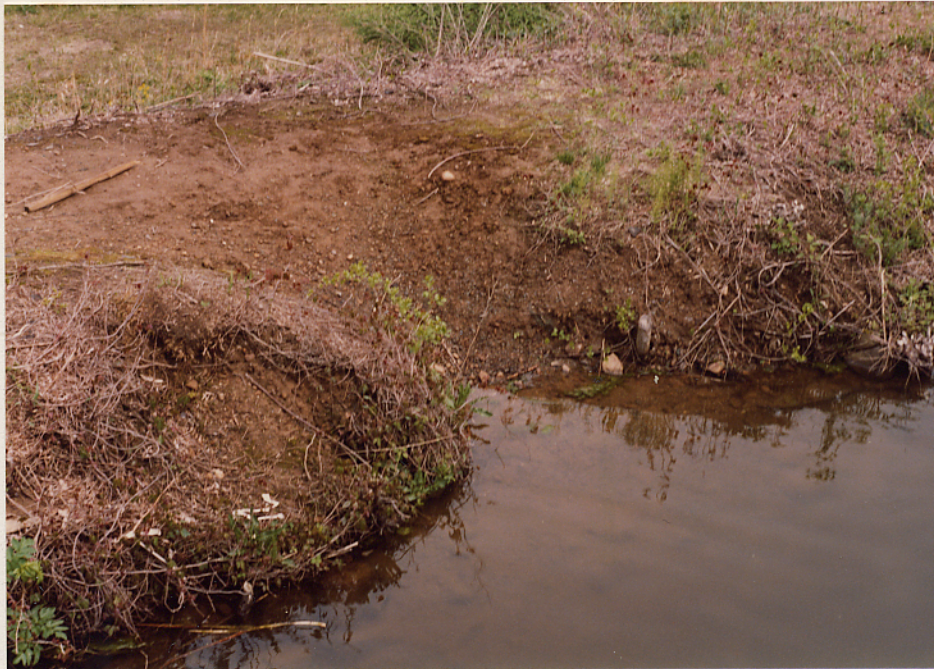
Photo 5 - Erosion on upstream slope just to the right of the gate house, (May, 1980).

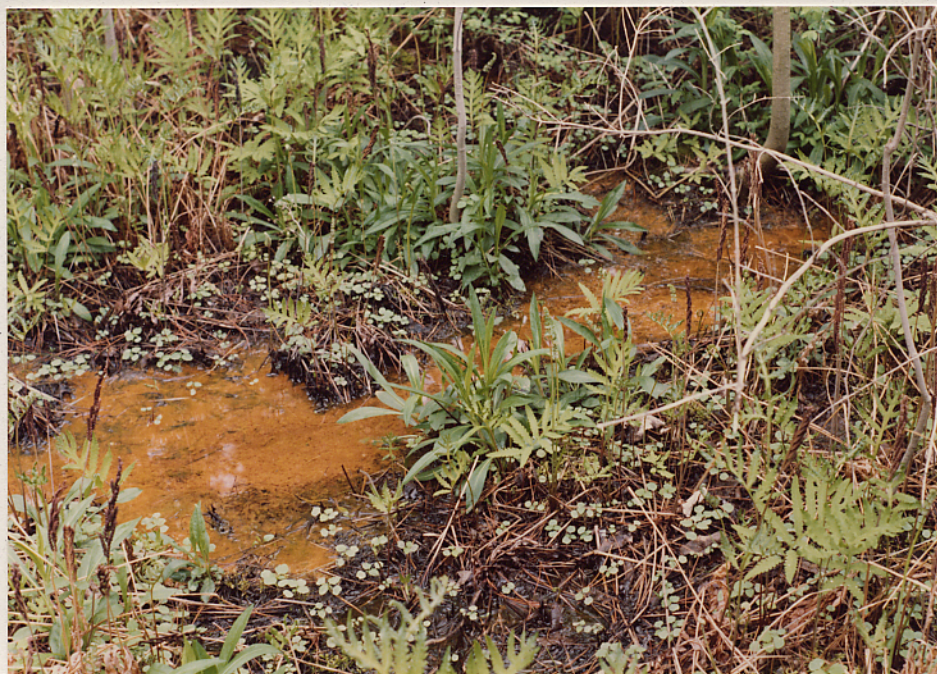
3. Areas of seepage and standing water at the toe of the slope could result in future stability problems if flows increase without detection.
4. The lack of proper operating and maintenance procedures and information concerning low-level outlets for lowering the reservoir, leaves the dam more susceptible to failure, as well as the owner unprepared, during high flooding conditions.

Photo 6 - Wet area with stagnant pool along toe of dam, (May, 1980).
